Re: Remediation and Closure Report
Maverick Permian, LLC
MCA 94 Flowline Leak
Unit Letter P, Section 20, Township 17 South, Range 32 East
Lea County, New Mexico
Incident ID# nAPP2212531906

Tetra Tech, Inc. (Tetra Tech) was contracted by Maverick Permian, LLC (Maverick) to complete the remediation of a release that occurred at the Maljamar Cooperative Agreement (MCA) 94 flowline, located in Unit Letter P, Section 20, Township 17 South, Range 32 East, in Lea County, New Mexico (Site). The release occurred at coordinates 32.81441°, -103.783172°, as shown in **Figure 1** and **Figure 2**.

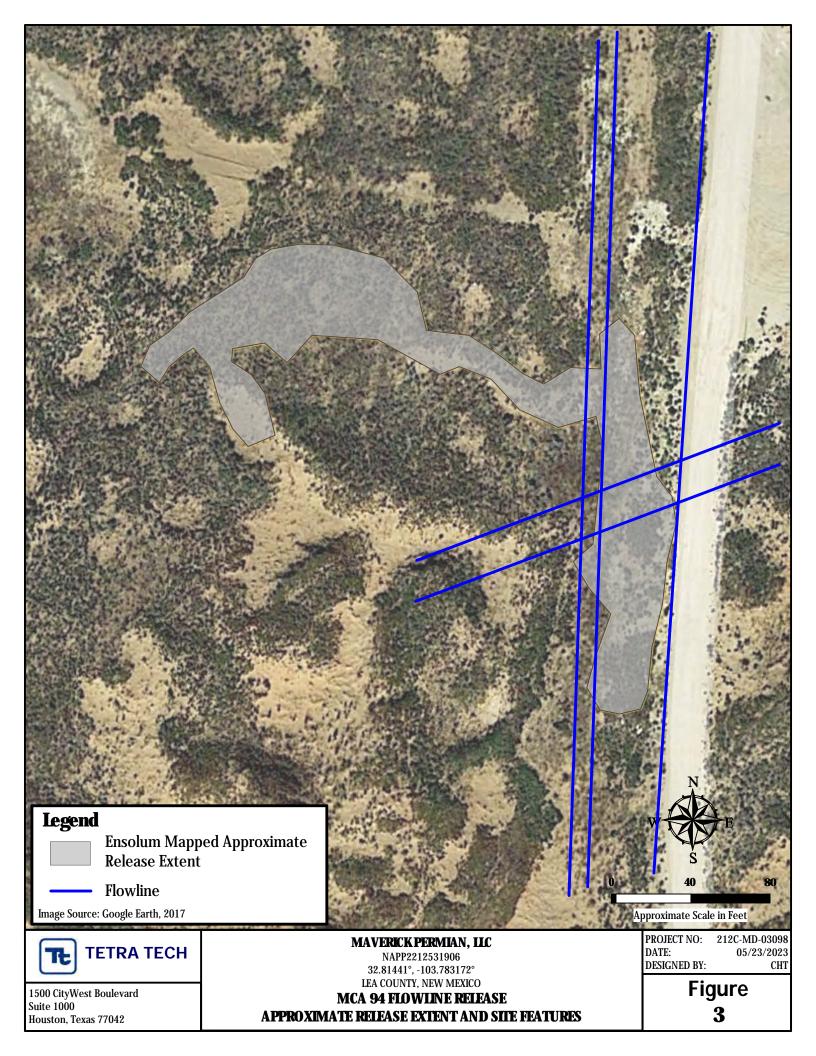
The release occurred due to a hole in a poly flowline resulting in the release onto an approximately 13,000 square foot area in open pasture where fluids pooled, as shown in **Figure 3**. According to Site records, no fluids were recovered during initial response activities undertaken by the former operator, ConocoPhillips Company (COP). COP sold the Site to Maverick who took over operations in June 2022, and COP postponed remedial activities until the asset sale was finalized. Confirmation samples were not collected during the initial response activities. The approximate release area is shown in **Figure 3**.

Between October 3 and October 6, 2022, Ensolum personnel conducted delineation activities at the Site to assess the vertical and lateral extent of chloride impacts to soil. Potholes PH01 through PH06 were excavated with a track-mounted backhoe within and around the release extent. The potholes were excavated depths of approximately 12 feet bgs before refusal was encountered. Ensolum collected discrete delineation soil samples were collected from each pothole at depths ranging from 1 to 12 feet bgs. Soil from the potholes was field screened for VOCs and chloride. Field screening results and observations of material excavated from potholes were logged on lithologic/soil sampling logs, which were previously submitted to the NMOCD in the Revised Remediation Workplan on December 22, 2022. The Ensolum delineation soil sample locations are depicted in **Figure 3**.

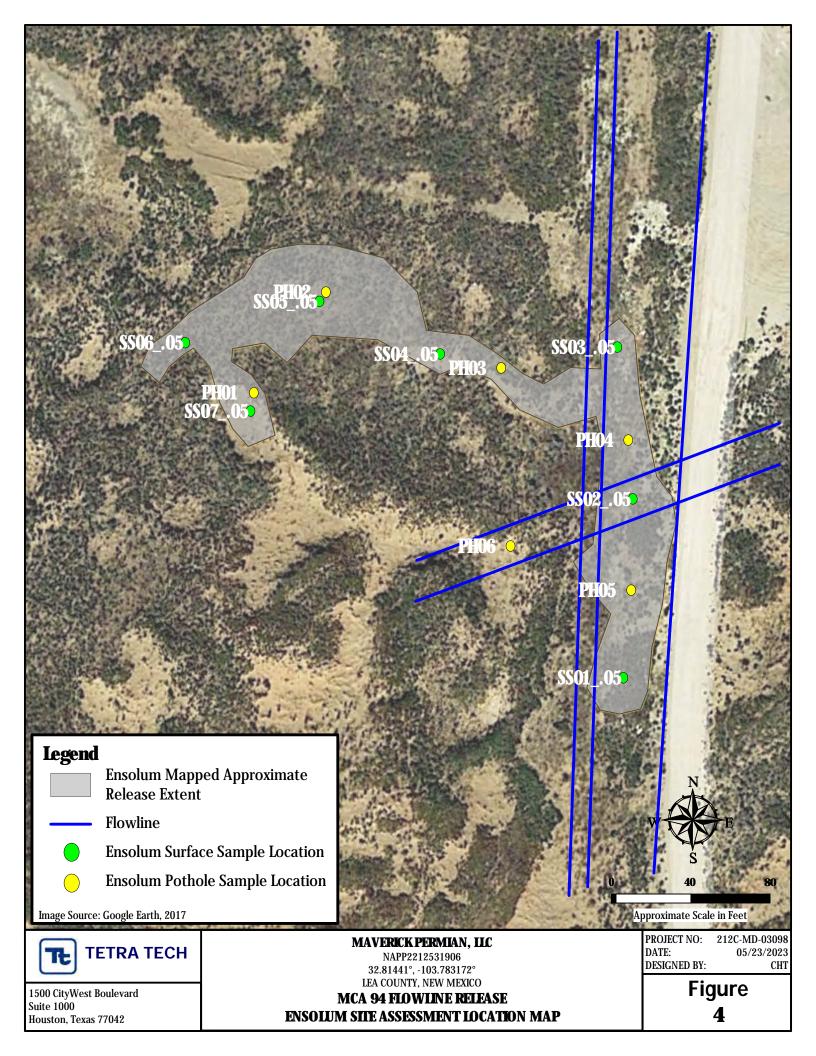
extents of areas requiring remediation at the Site. Tetra Tech advanced 26 hand auger borings around the release Site as shown in **Figure 4.**

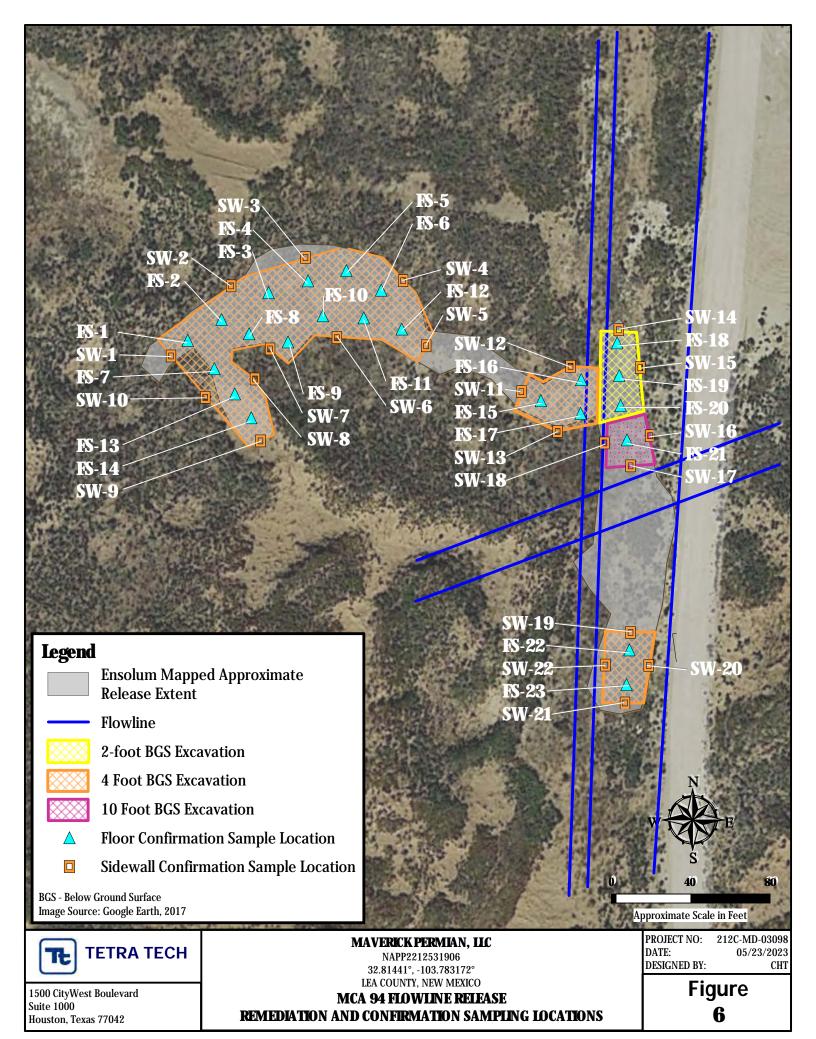
Upon reaching the final lateral and vertical excavation extents of the excavation, Tetra Tech collected 45 confirmation samples, including 23 floor samples and 22 side wall samples from the excavated areas. confirmation samples were submitted to Cardinal Laboratory in Hobbs, New Mexico for analysis of chloride (SM4500 CL-B). Laboratory analytical results for submitted confirmation samples reported concentrations of chloride as less than respective Reclamation Requirements for samples collected from depths above 4 feet bgs. For all samples obtained at or below a depth of 4 feet bgs, laboratory analytical results reported constituent concentrations as less than RRALs, and clean margins were demonstrated.

On May 10, 2023, subsequent to the receipt of confirmation sample results, McNabb completed backfilling of the excavated areas with clean soil. Confirmation sampling laboratory analytical results screened against Reclamation Requirements and RRALs are summarized in **Table 5** and **Table 6** and laboratory analytical data packages including chain of custody documentation are included in **Attachment 3**. Photographic Documentation showing the excavated areas and final grading after backfilling is provided in **Attachment 4**.

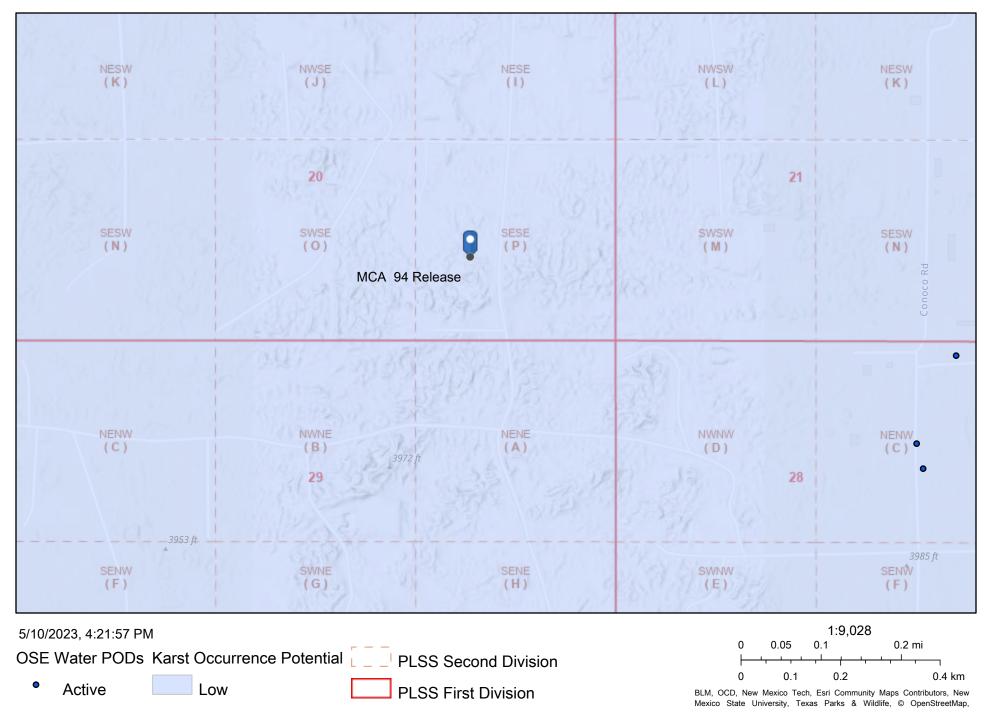
MCA 94 Site Characterization

Ensolum, LLC (Ensolum) performed a site characterization furnished to the NMOCD in previous submittals under this incident number. Tetra Tech performed a separate site characterization for the release location to verify the previously submitted information and fill data gaps. Tetra Tech did not identify any watercourses, sinkholes, playas, residences, schools, hospitals, institutions, churches, springs, private domestic water wells, wetlands, incorporated municipal boundaries, subsurface mines, or floodplains within the distances specified in 19.15.09 New Mexico Administrative Code (NMAC). Based on a review of the NMOCD Mapper The Site is in an area of low karst potential, as shown in **Attachment 2**.
